# Manhole Inspection Summary

Manhole # S15C1\_016MH

Insp Date: **5/28/08 10:31 AM**

**Location** Address: **2960 james st**

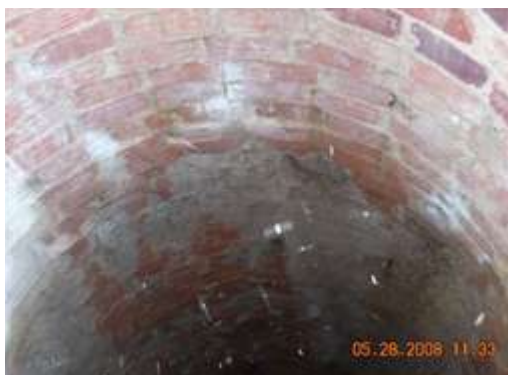
Defect 3

Infiltration: ☐ None ☐ Joint ☐ Cracks ☐ Mortar ☐ Roots ☒ **Wall**

infiltration @ barrel wall

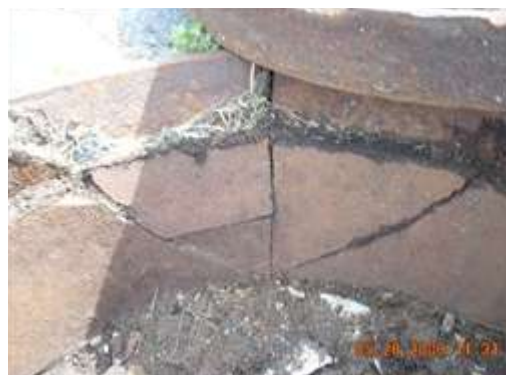
Defect 2

Infiltration: ☐ None ☐ Joint ☐ Cracks ☐ Mortar ☐ Roots ☒ **Wall**

infiltration @ corbel wall

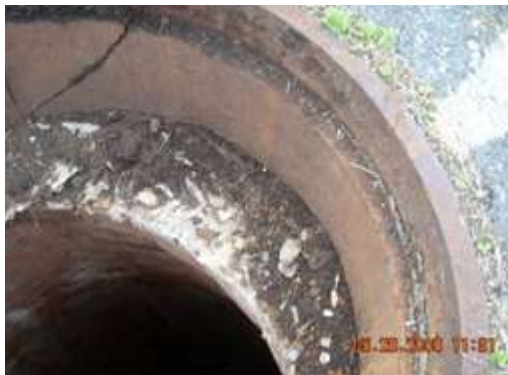
### Defect 1

☒ **Cracked**

cracked/broken frame

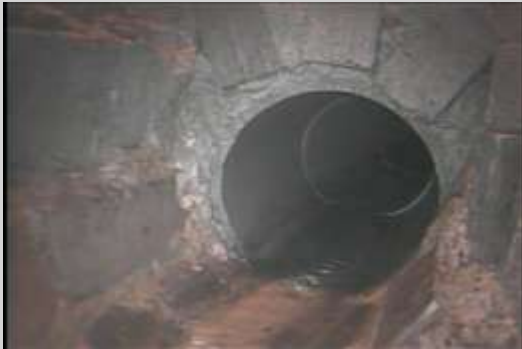
12 O'Clock Outflow

8 in. Circular Gravity Sewer  
Pipe Out @ 12 O'Clock

Pipe Height: **8.4** (in.) Rod and Bar (Angled)  
Pipe Material: **Clay** ☐ Pipe Lined  
Invert Depth: **15.38** (ft.) Flow Characteristics: **Slow**  
Deposits: ☒ None ☐ Mud ☐ Sludge ☐ Debris ☐ Grease  
Silt Depth: **0** (in.) Deposits Extent:  
Infiltration: **None** Pipe Seal Cond: **Sound**

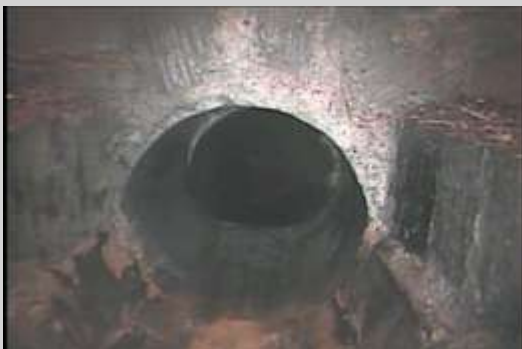
3 O'Clock Inflow

8 in. Circular Gravity Sewer  
Pipe In @ 3 O'Clock

Pipe Height: **8.4** (in.) Rod and Bar (Angled)  
Pipe Material: **Clay** ☐ Pipe Lined  
Invert Depth: **15.29** (ft.) Flow Characteristics: **Slow**  
Deposits: ☒ None ☐ Mud ☐ Sludge ☐ Debris ☐ Grease  
Silt Depth: **0** (in.) Deposits Extent:  
Infiltration: **None** Pipe Seal Cond: **Sound**
